## **Composite Failure Analysis Handbook Update #1**

*Greg Walker*

*Boeing Defense & Space Group*

**April 1995**

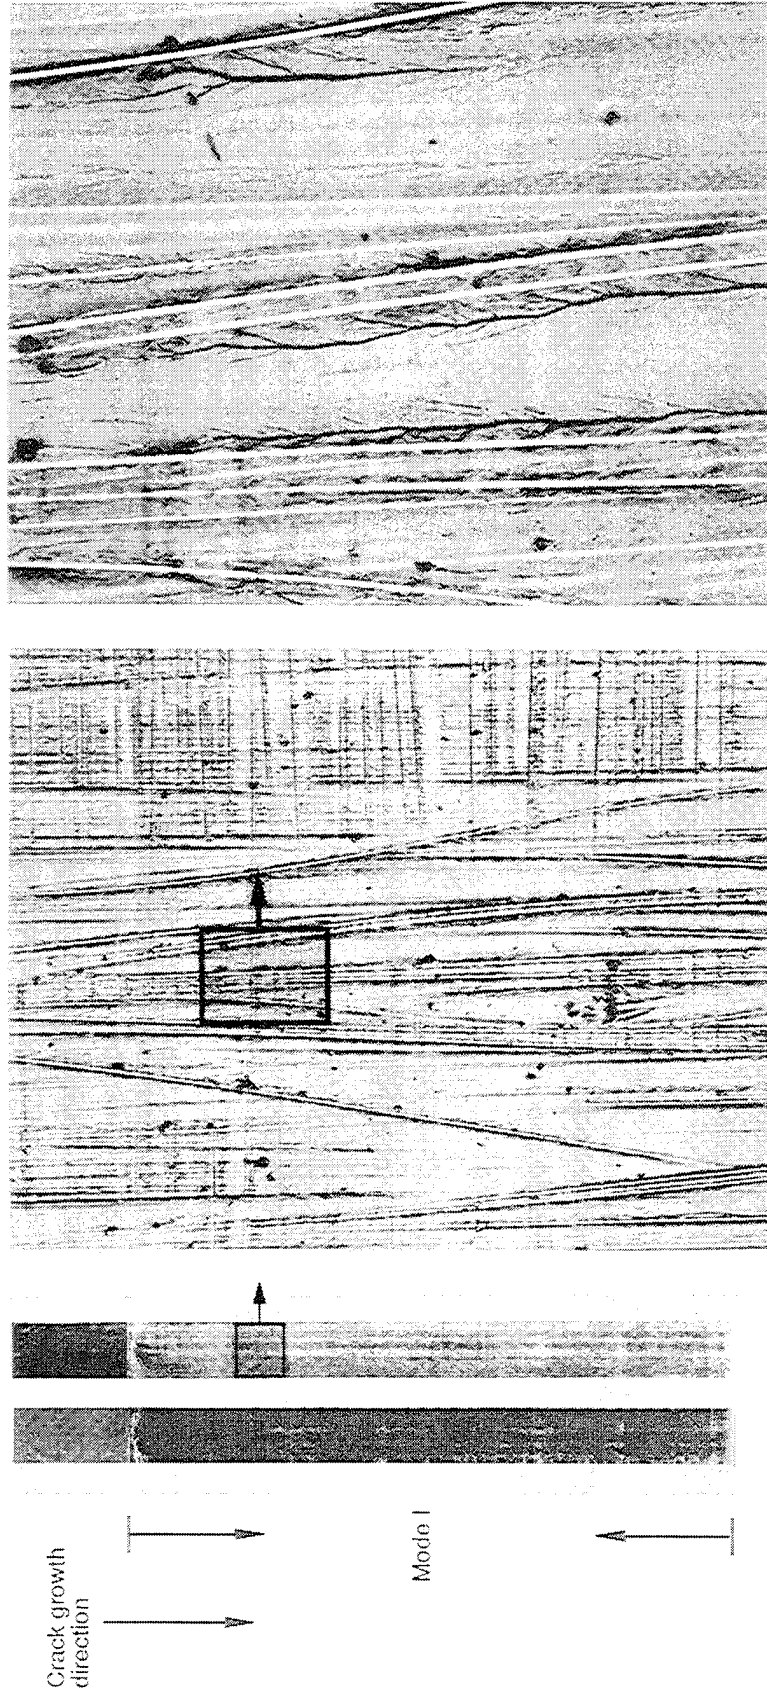
Figure 3.1-23. Optical Fractography of 3501-6/AS4 Interlaminar Mode I Tension Specimen, Moisture/Dryout Cycled

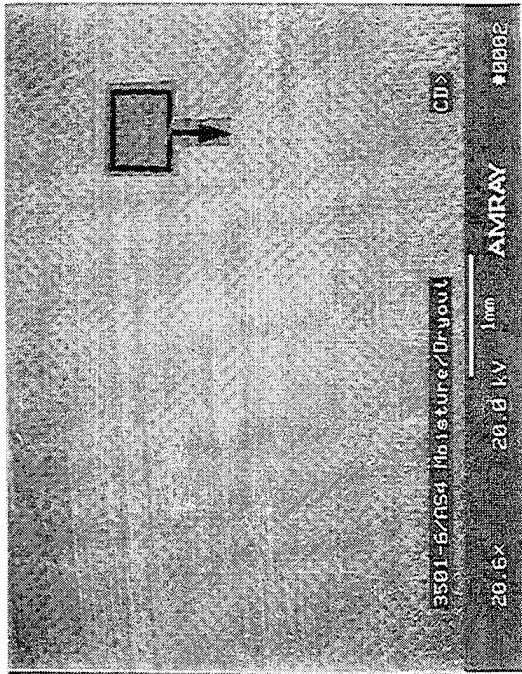
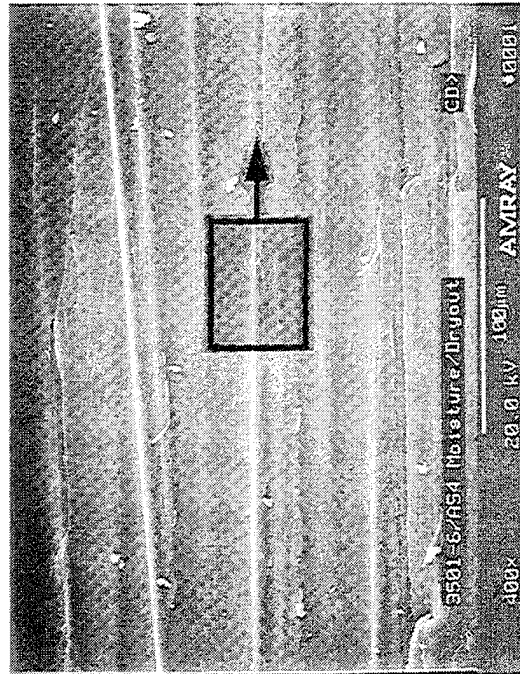
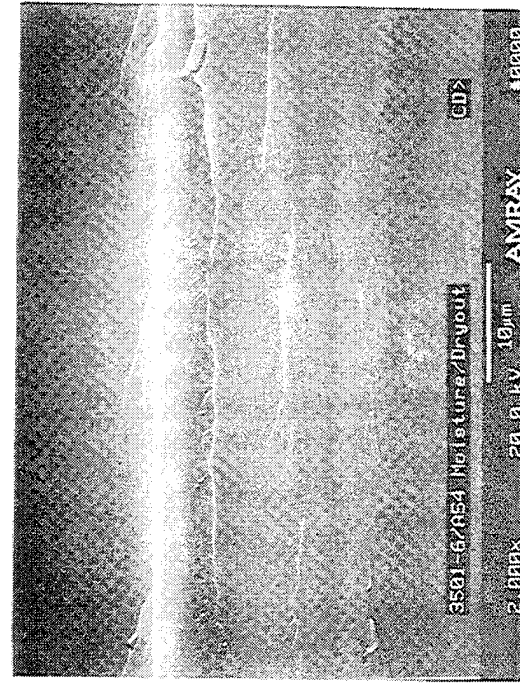
Figure 3.1-24. SEM Fractographs of a 3501-6/AS4 Interlaminar Mode I Tensile Fracture Surface Tested After Moisture/Dryout Cycling

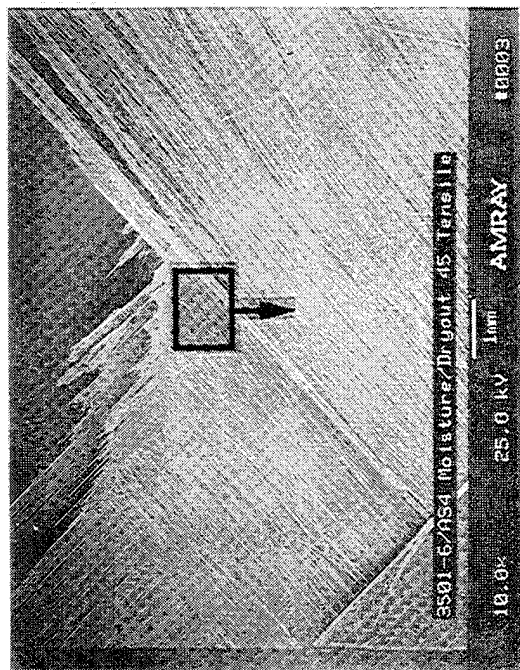
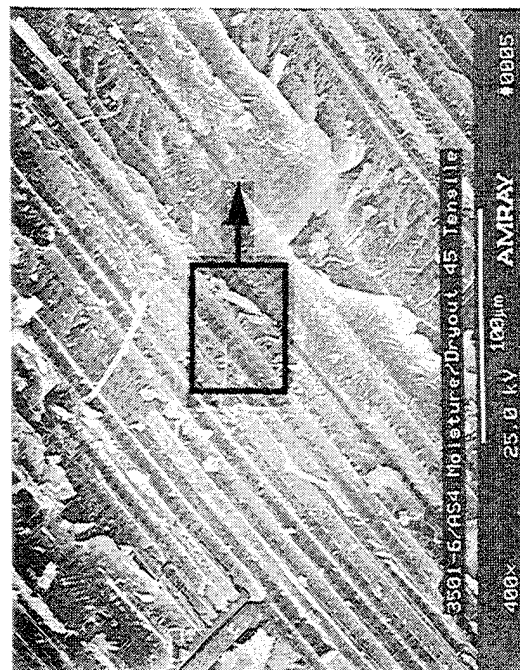
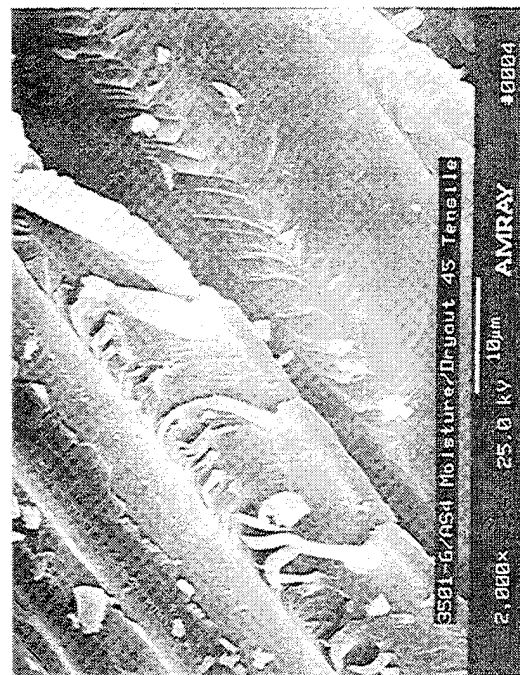
Figure 3.1-25. SEM Fractographs of a 3501-6/AS4  $\pm 45^\circ$  Tensile Specimen Tested After Moisture/Dryout Cycling, Interlaminar Surface

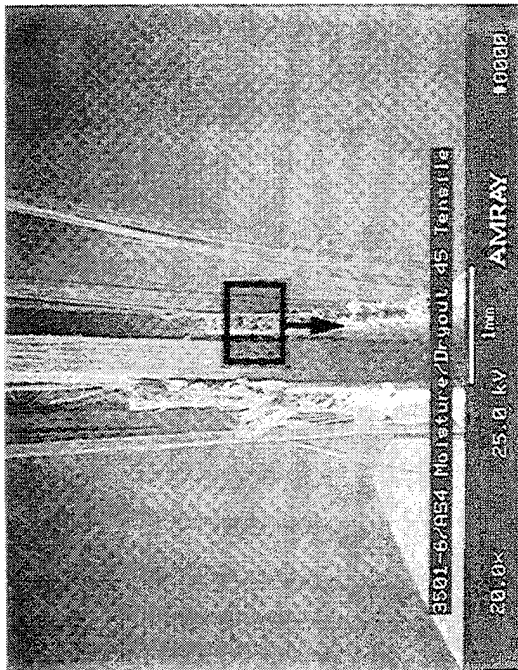
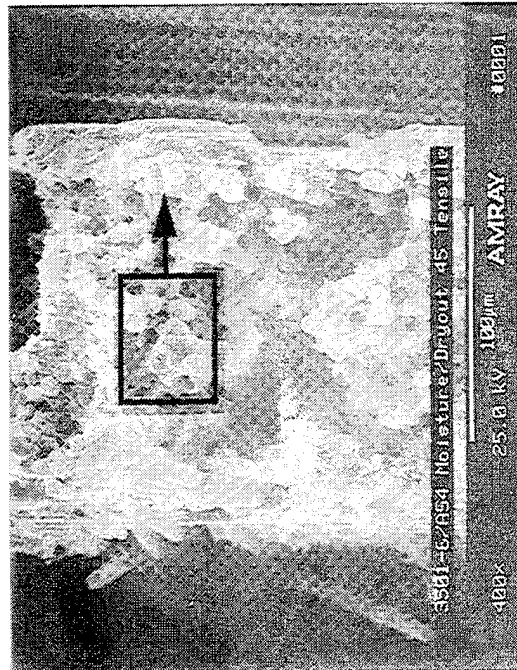
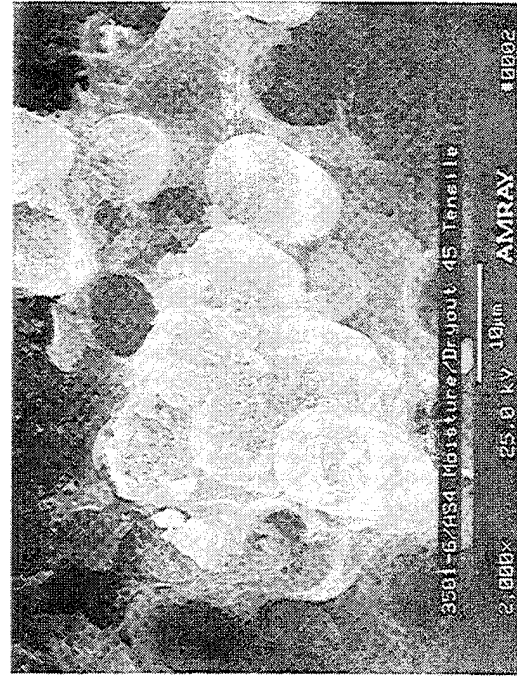
Figure 3.1-26. SEM Fractographs of a 3501-G/AS4  $\pm 45^\circ$  Tensile Specimen Tested After Moisture/Dryout Cycling, Translaminar Surface

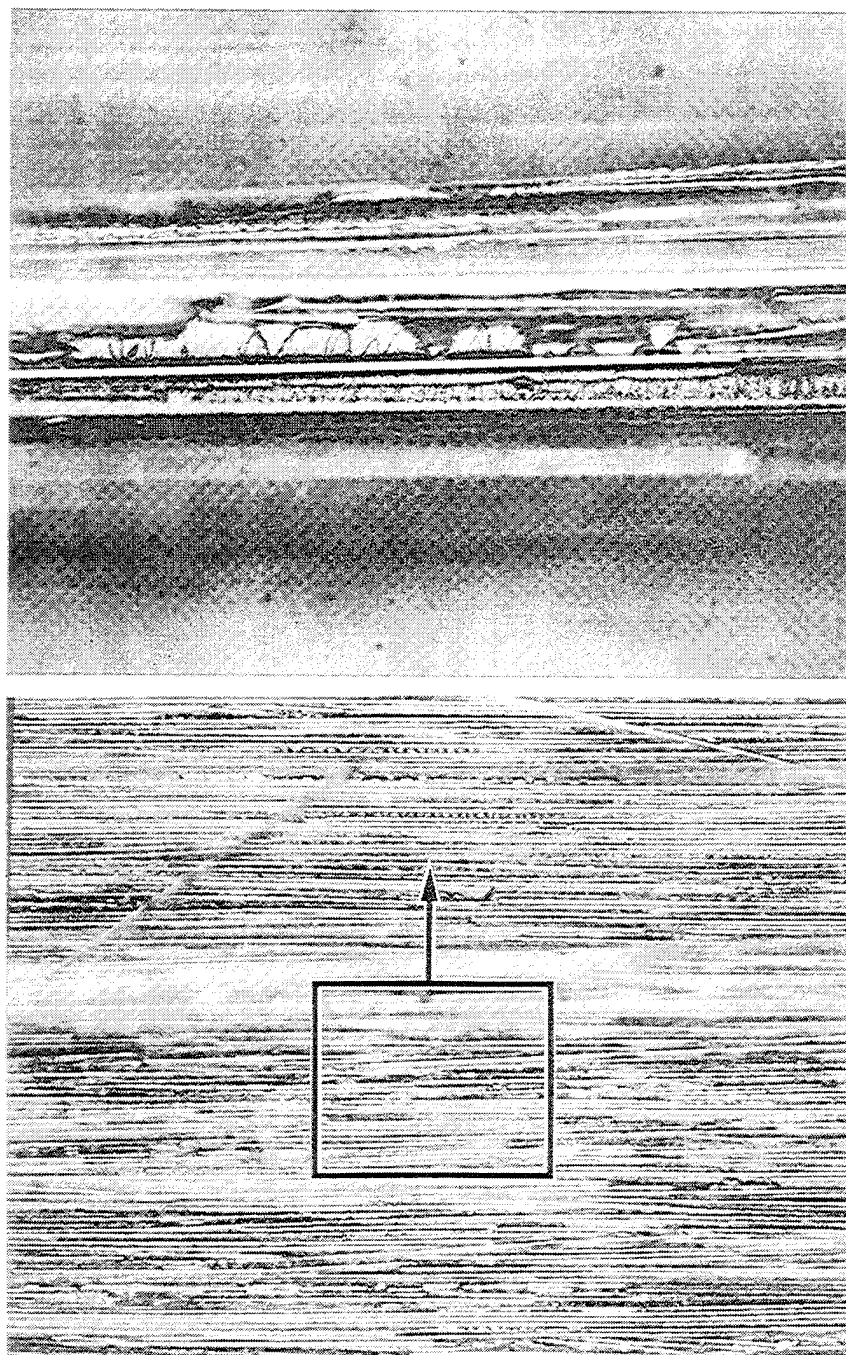
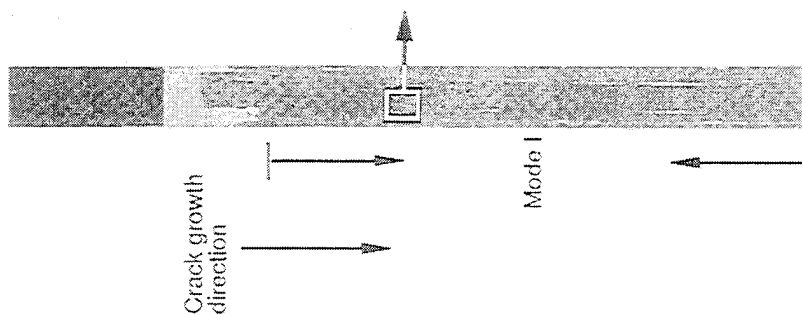
The fracture morphology of the specimens exhibited similar features as those of the PEEK material system, which is a true thermoplastic. On a macroscopic scale, numerous loose fibers were on the surface due to fiber pull-out. Microscopically, these features include the slow ductile peeling of the matrix craze filaments, which produce a limited river pattern and some cusps, which are generally associated with mode II (shear) loading (Figures 3.2-1 and 3.2-2).

Figure 3.2-1. Optical Fractography of KIIII/AS4 Interlaminar Mode I Tension Specimen Tested at RT/Dry

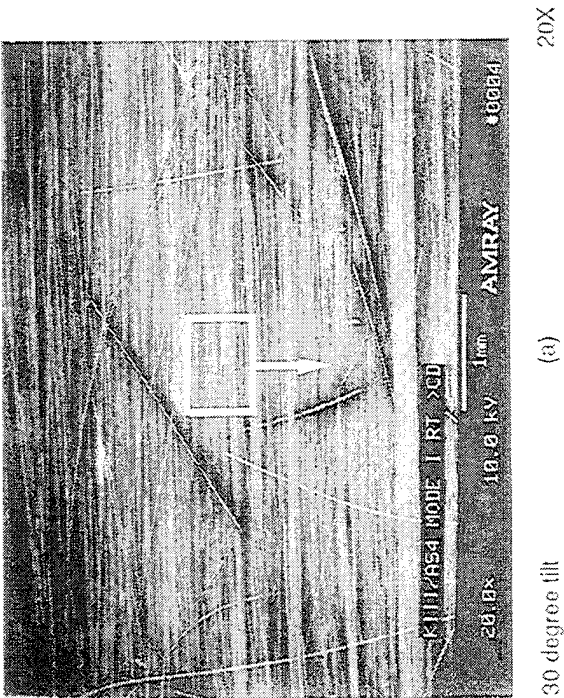
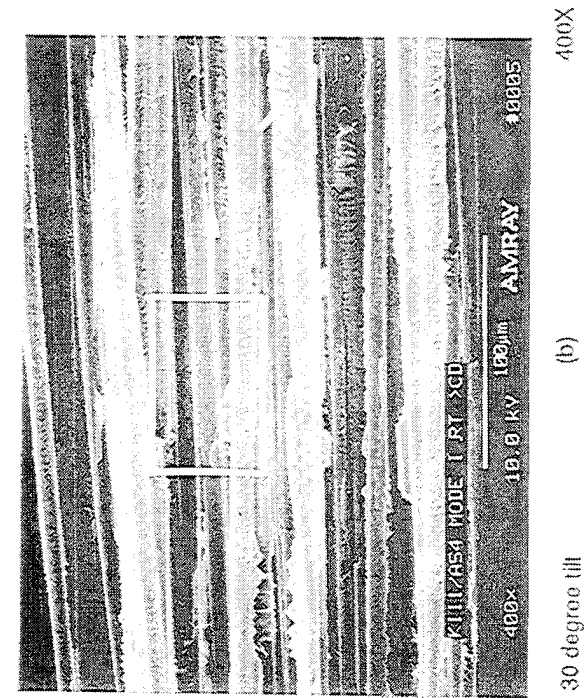
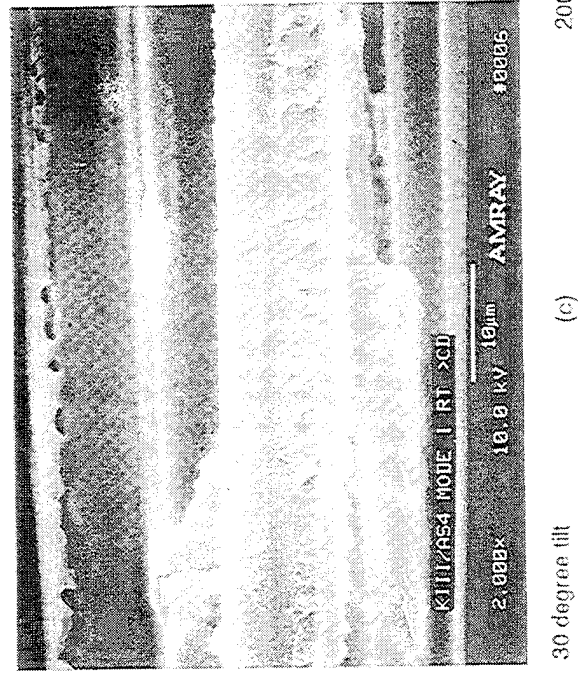
Figure 3.2-2. SEM Fractographs of a K111/AS4 Interlaminar Mode I Shear Fracture Surface Tested at RT/Dry

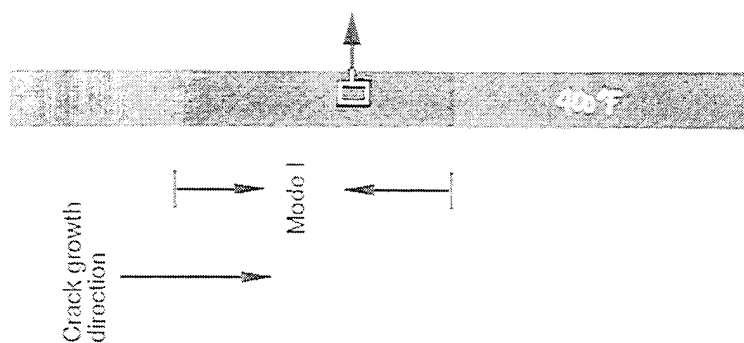
This fracture surface was generally similar to the RT surface but with minor differences such as fibers pulled out from the surface and slightly larger matrix craze filaments (Figures 3.2-3 and 3.2-4).

Figure 3.2-3. Optical Fractography of KII/AS-4 Interlaminar Mode I Tension Specimen Tested at 400°F/Dry

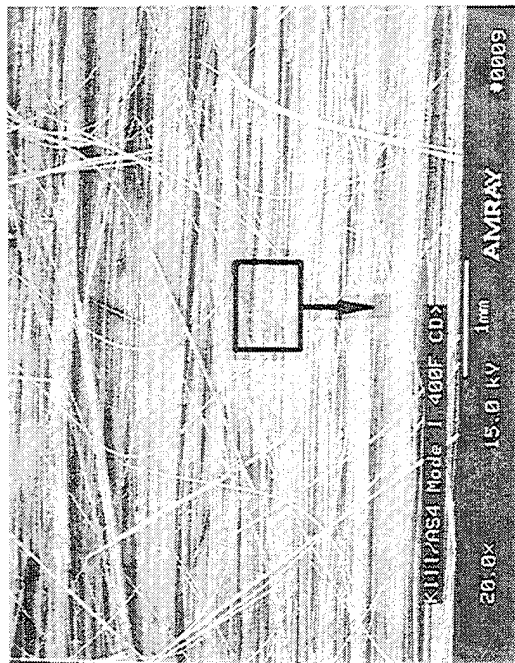
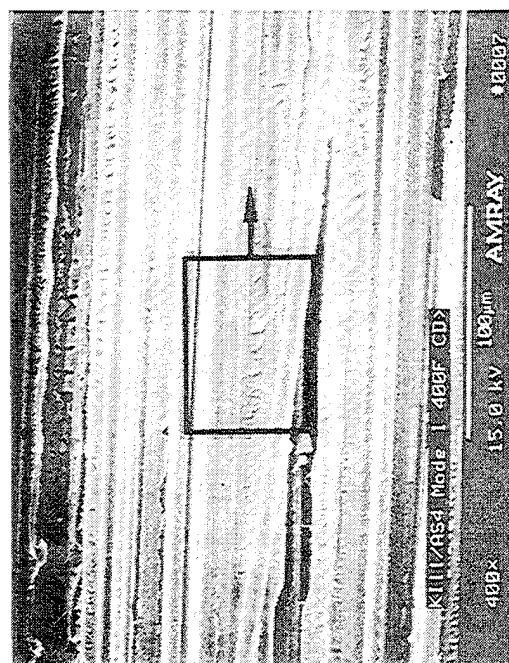
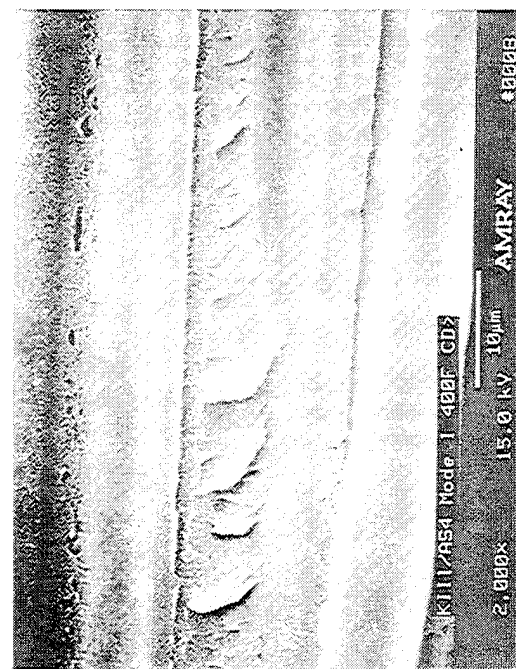
Figure 3.2-4. SEM Fractographs of a KIII/AS4 Interlaminar Mode I (Tension) Fracture Surface, 400°F

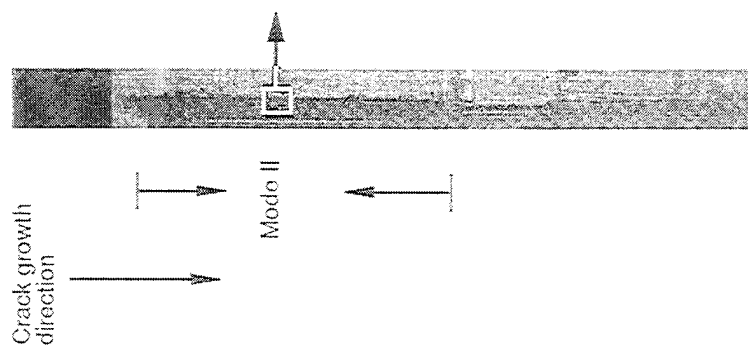
As with the mode I (tensile) case, the mode II (shear) surface morphology exhibited features similar to those of the PEEK specimens, except that there were no loose fibers on the surface. This morphology was also similar to the KIII/AS4 mode I surface, making it difficult to determine the loading condition (Figures 3.2-5 and 3.2-6).

Figure 3.2-5. Optical Fractography of KIII/ASA Interlaminar Mode II Shear Specimen Tested at RT/Dry

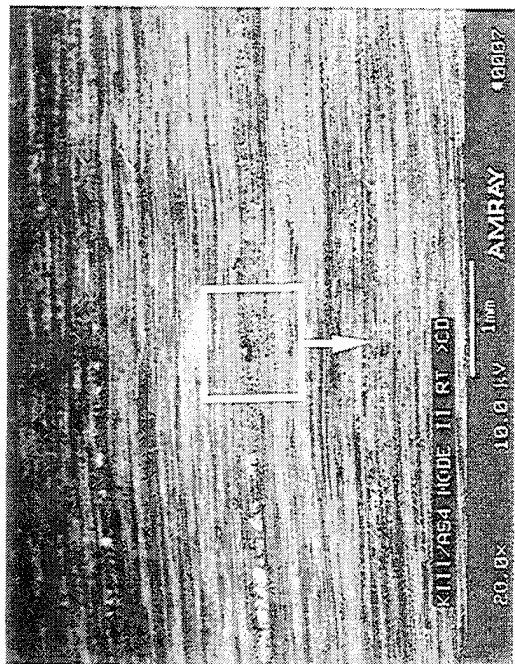
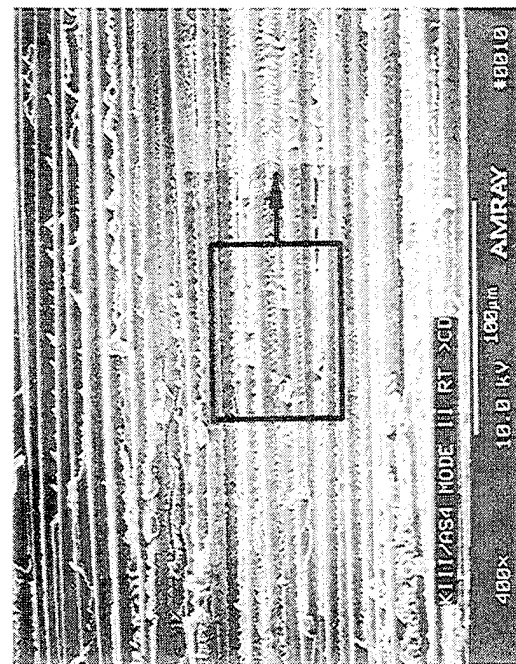
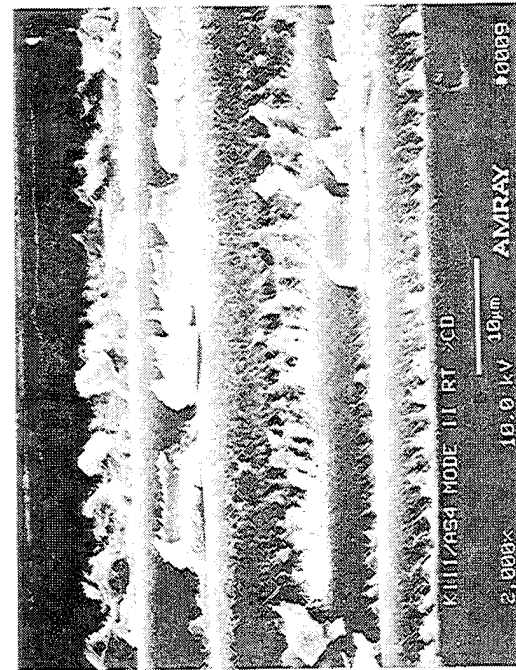
Figure 3.2-6. SEM Fractographs of a K1117/AS4 Interlaminar Mode II Shear Fracture Surface

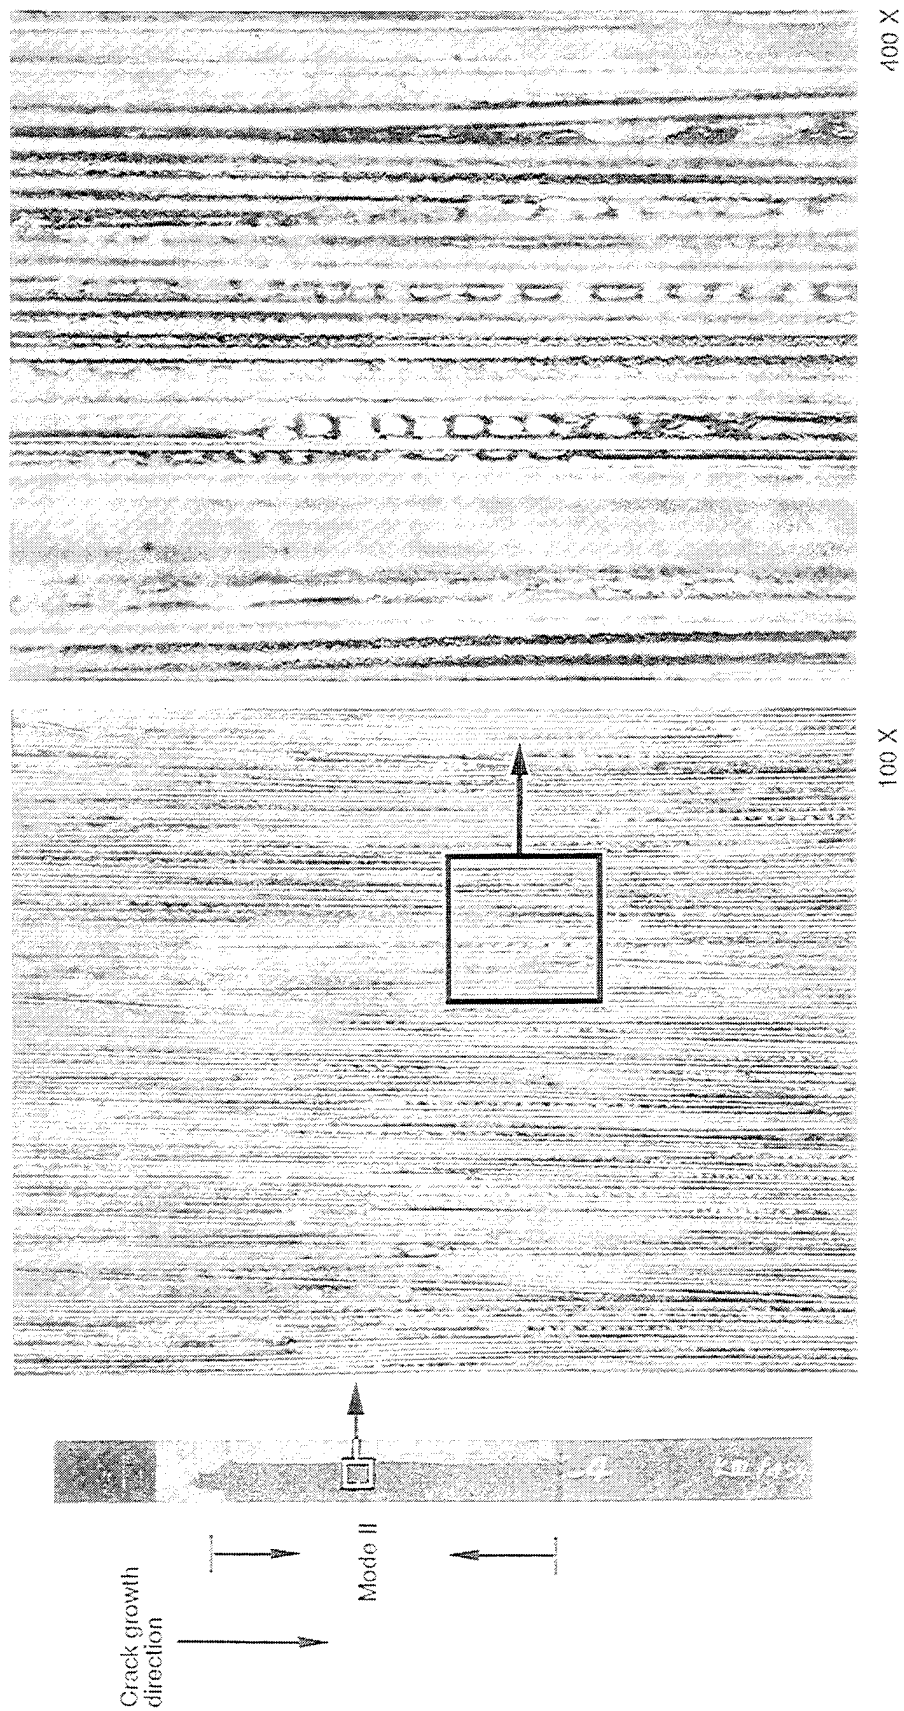
There were no significant differences between the fracture morphology of the RT and the elevated temperature test specimens as shown in Figures 3.2-7 and 3.2-8.

Figure 3.2-7. Optical Fractography of KII/AS4 Interlaminar Mode II Shear Specimen Tested at 400° F/Dry

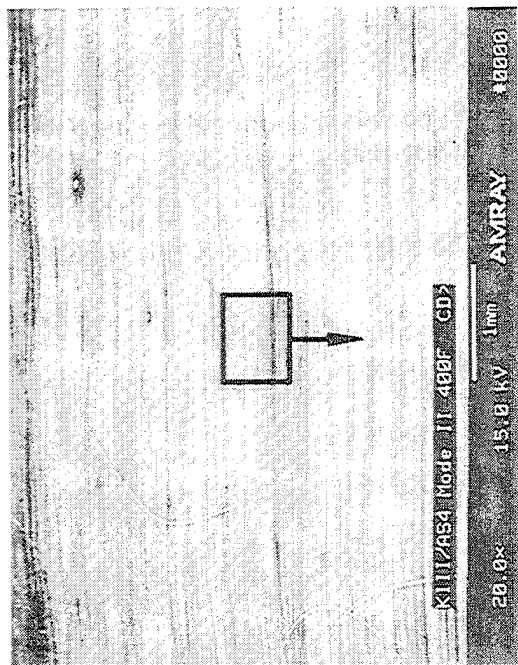
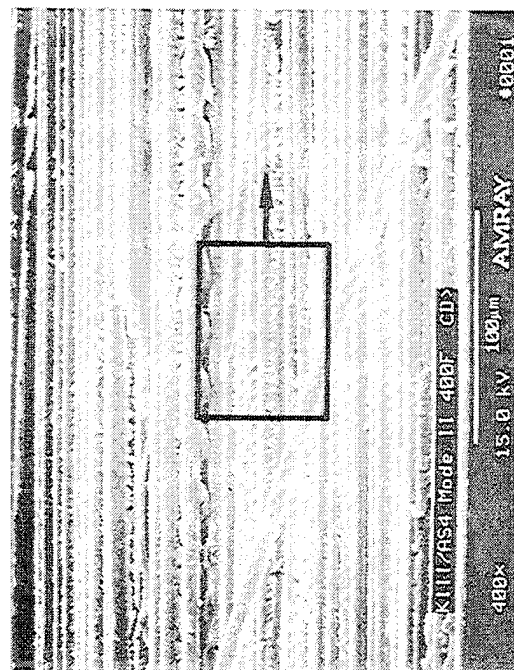
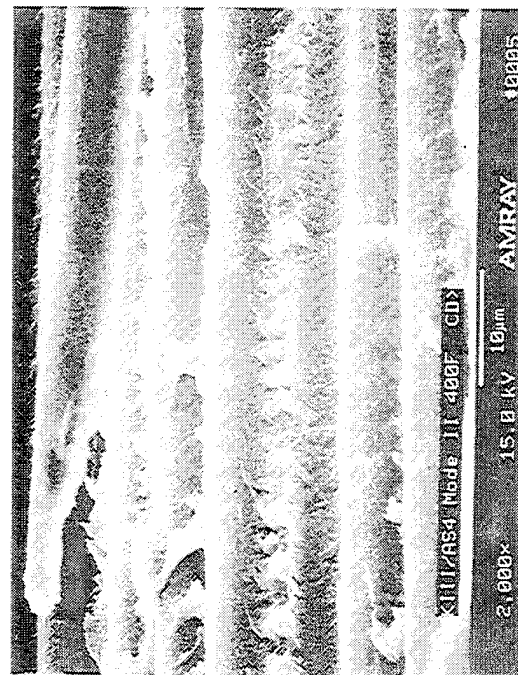
Figure 3.2-8. SEM Fractographs of a KIII/AS4 Interlaminar Mode II (Shear) Fracture Surface, 400°F

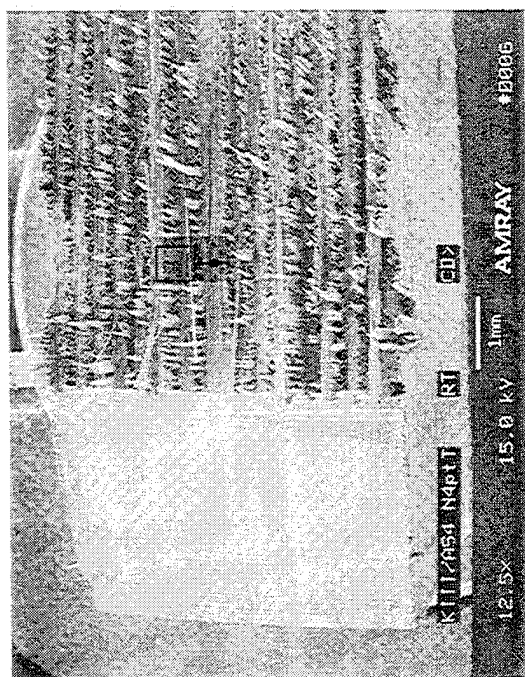
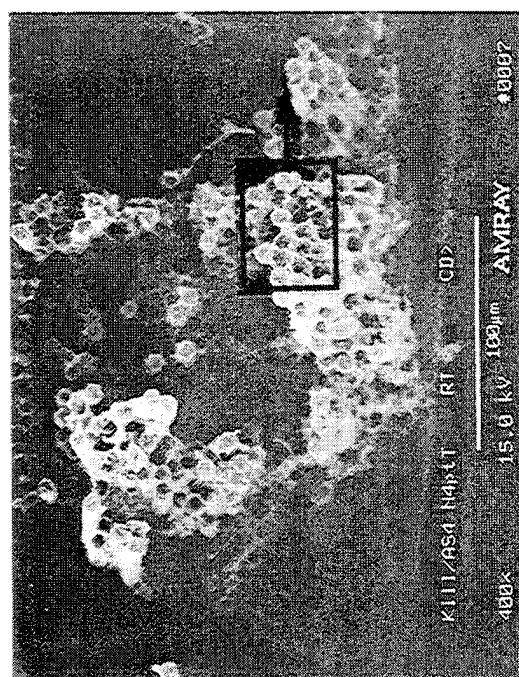
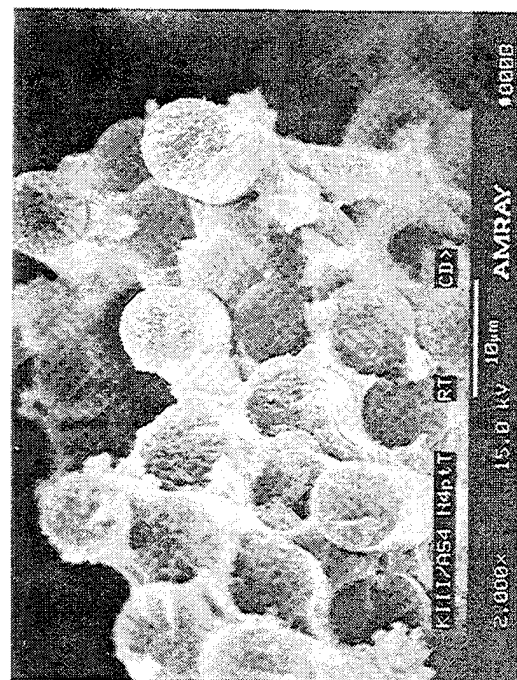
The overall appearance of the room temperature fracture morphology was typical of a notched four-point tensile specimen, exhibiting a very jagged surface. The fracture origins on the fiber ends were easily visible and generally indicated the overall mechanically induced crack direction (Figure 3.2-9). The interlaminar surfaces (Figure 3.2-10) were identical to the mode I fracture morphology as described above.

Figure 3.2-9. SEM Fractographs of a K1117AS4 N4ptT Specimen, Transverse Fracture Surface, Room Temperature

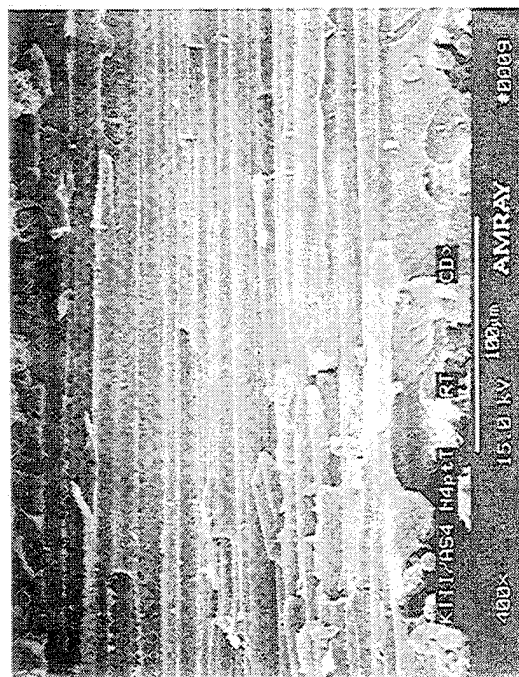
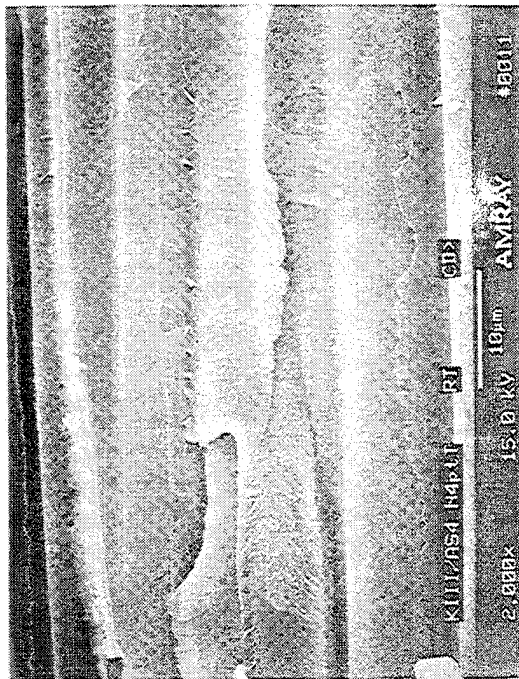
Figure 3.2-10. SEM Fractographs of a KIII/AS4 M4ptI Specimen, Interlaminar Surface, Room Temperature

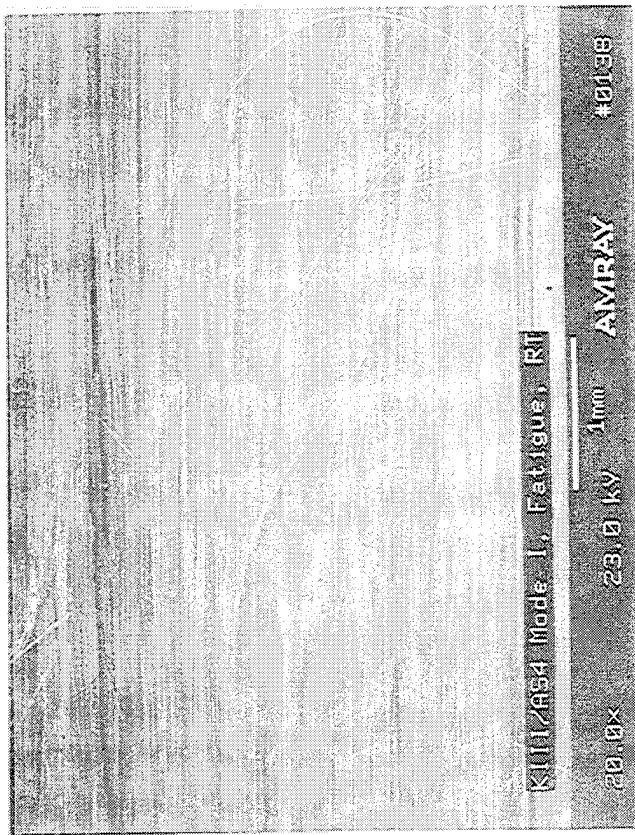
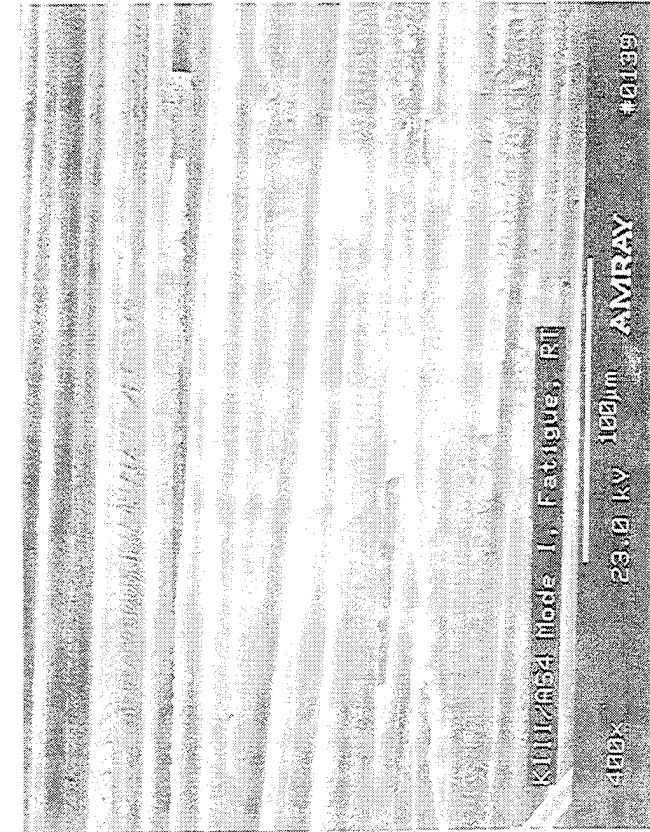
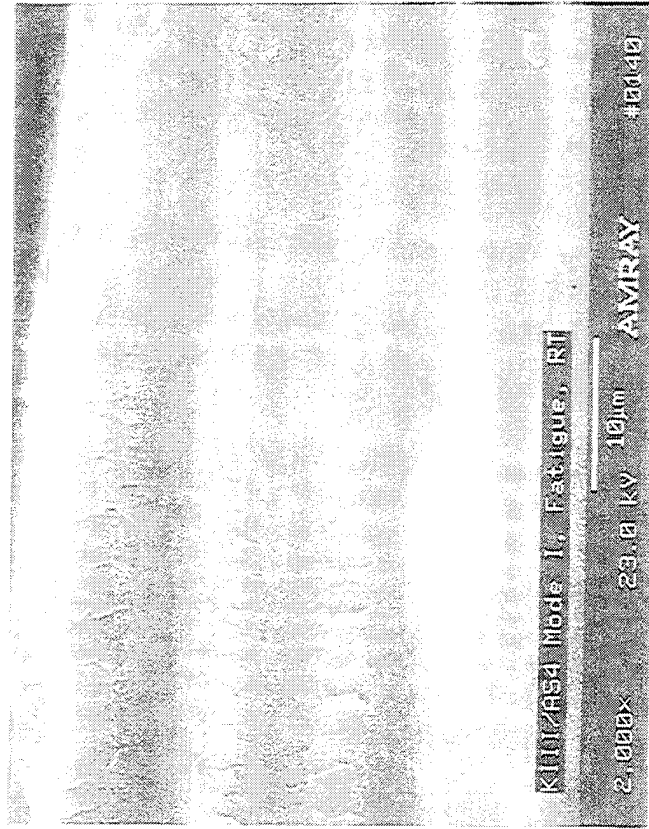
Both the RT (Figures 3.2-11 & 3.2-12) and the 350°F tested specimens (Figures 3.2-13 & 3.2-14) exhibited similar fracture features which appeared to resemble a mode II (shear) morphology. The resin material between the fibers contained hackles which indicated the overall crack growth orientation. No rivermarks or other distinctive mode I features were observed.

Figure 3.2-12. SEM Fractographs of a KIII/AS4 Interlaminar Mode I (Tensile) Fatigue Fracture Surface, RT

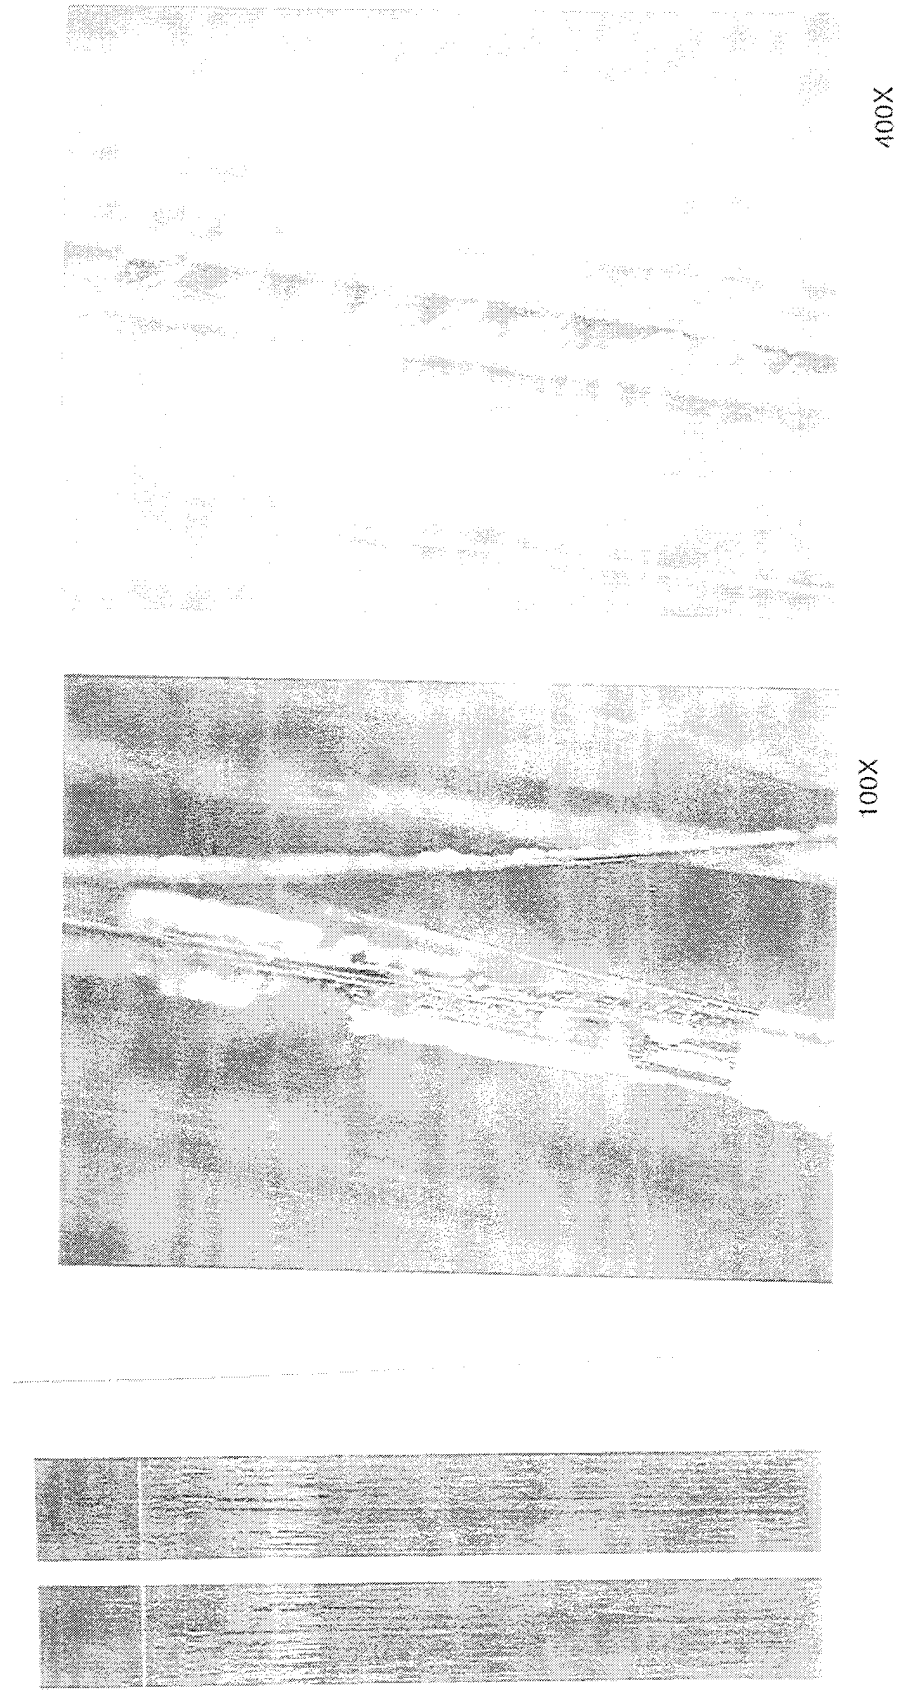
Figure 3.2-13. Optical Fractographs of a KII/AS4 Interlaminar Mode I (Tensile) Fatigue Fracture Surface, 350° F

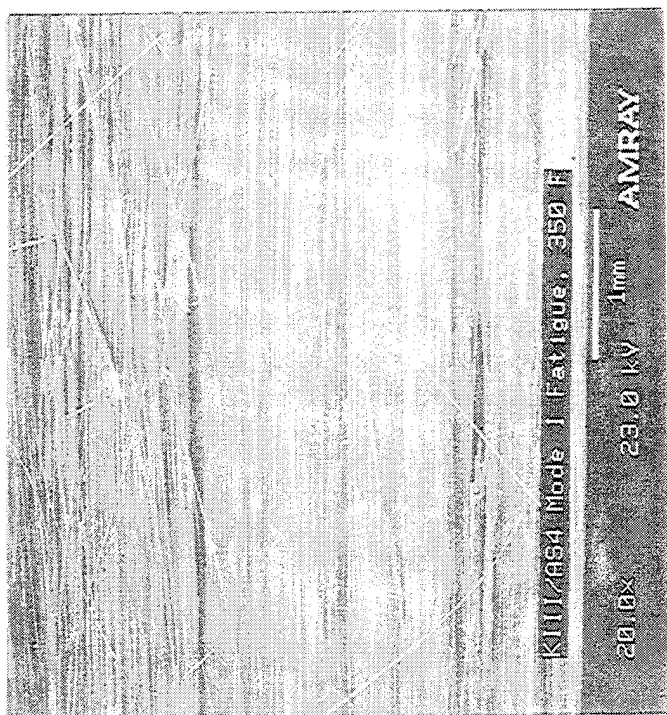
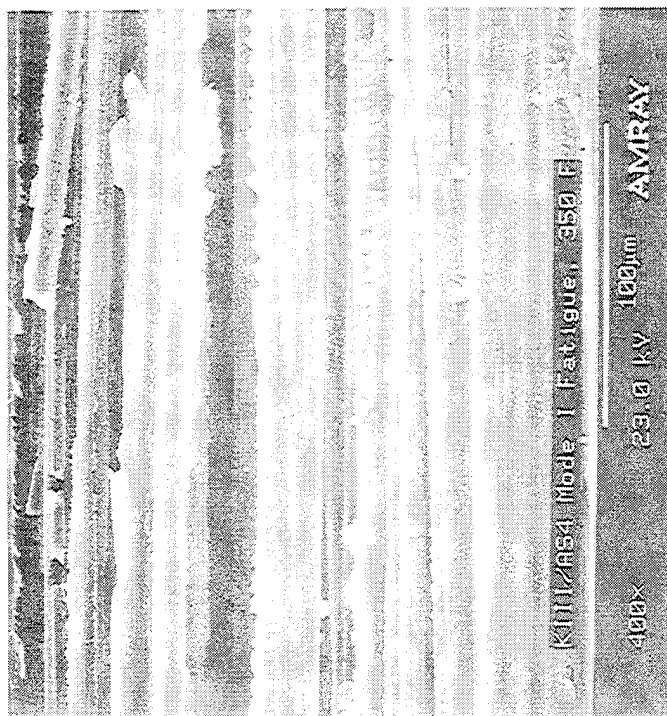
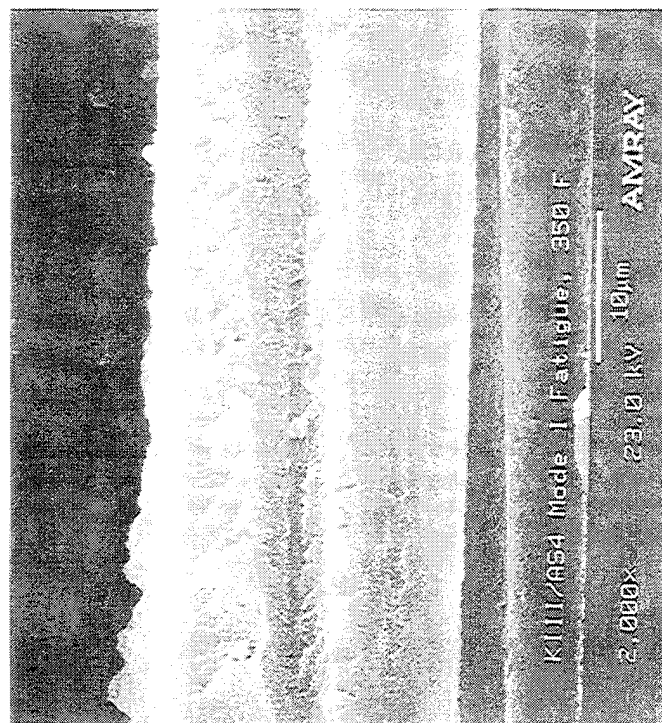
Figure 3.2-14. SEM Fractographs of a KIII/AS4 Interlaminar Mode I (Tensile) Fatigue Fracture Surface, 350° F

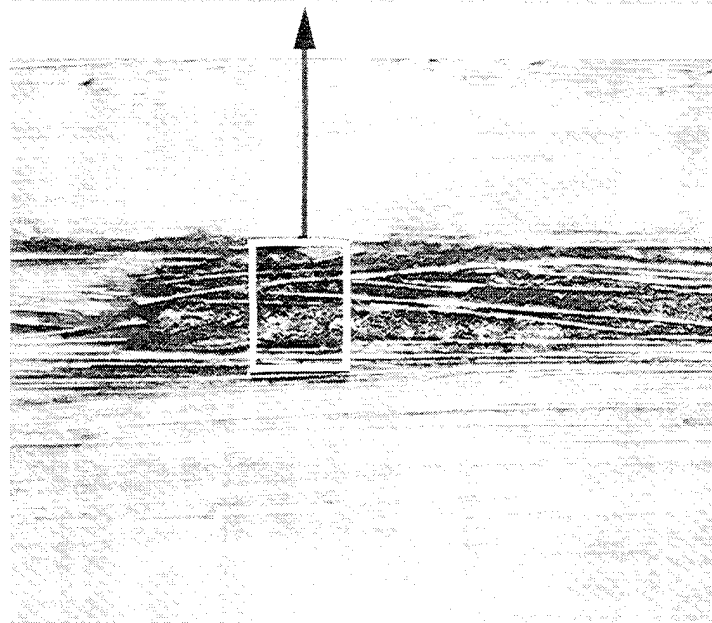
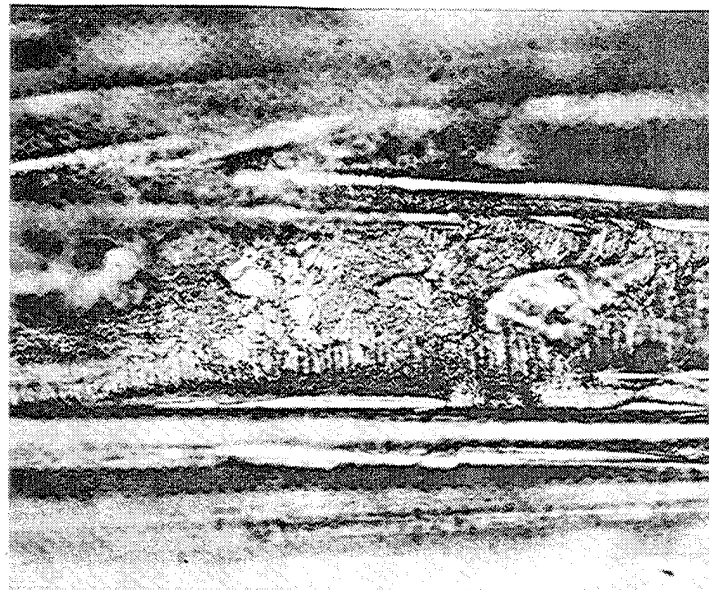
Examination of the fracture surfaces did not reveal any definite indications of fatigue, except for a feature that may be related to the cyclic loading. This feature appeared to be typical of a mode II hackle. However, when observed at high magnification the feature appears to be wider and thinner than similar hackles on statically loaded specimens. This feature was observed both on the RT specimen (Figures 3.2-15 and 3.2-16) and the 350°F tested specimens (Figures 3.2-17 and 3.2-18).

Fatigue  
region

Figure 3.2-15. Optical Fractographs of KIII/AS4 Interlaminar Mode II (Shear) Fatigue, Room Temperature, High Stress

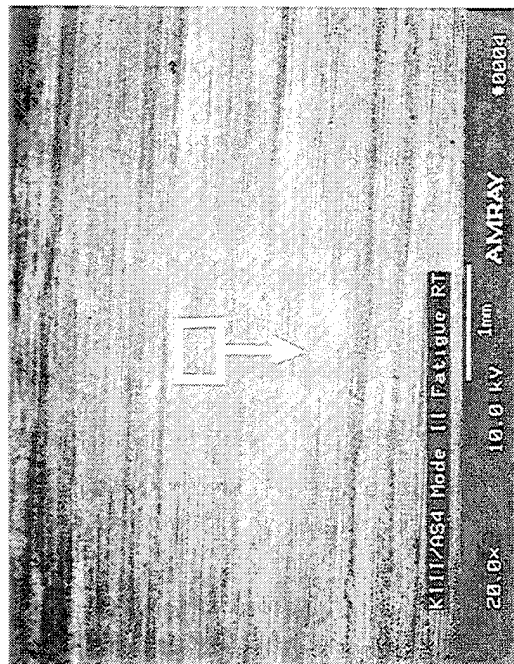
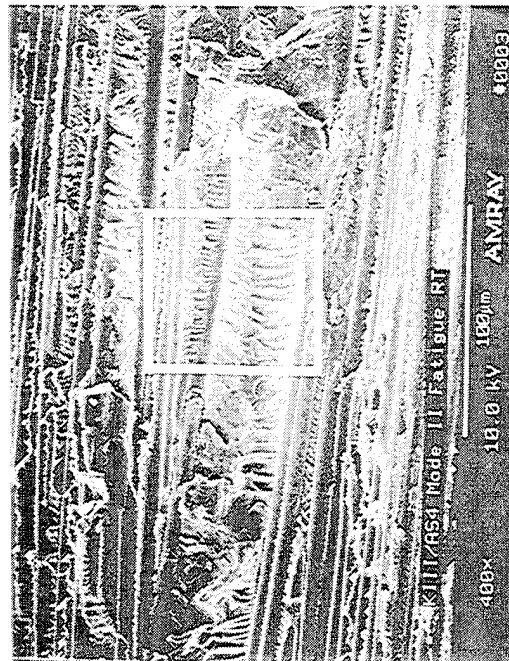
Figure 3.2-16. SEM Fractographs of a KIII/AS4 Interlaminar Mode II (Shear) Fatigue Fracture Surface, Room Temperature

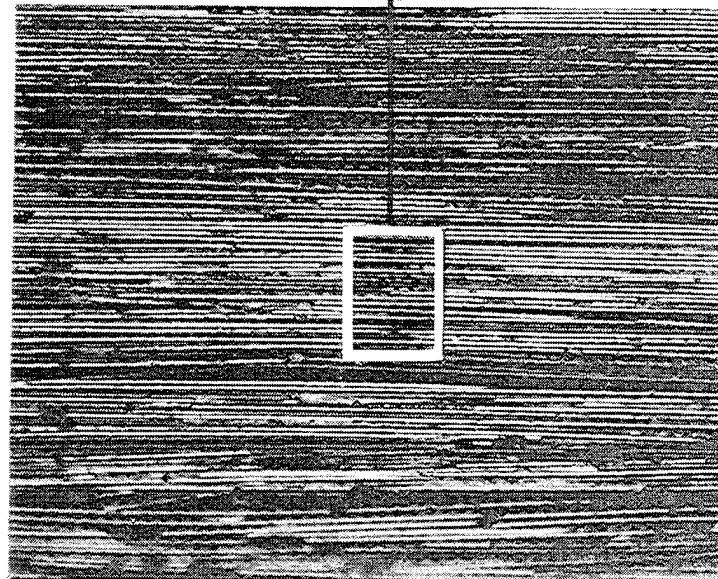
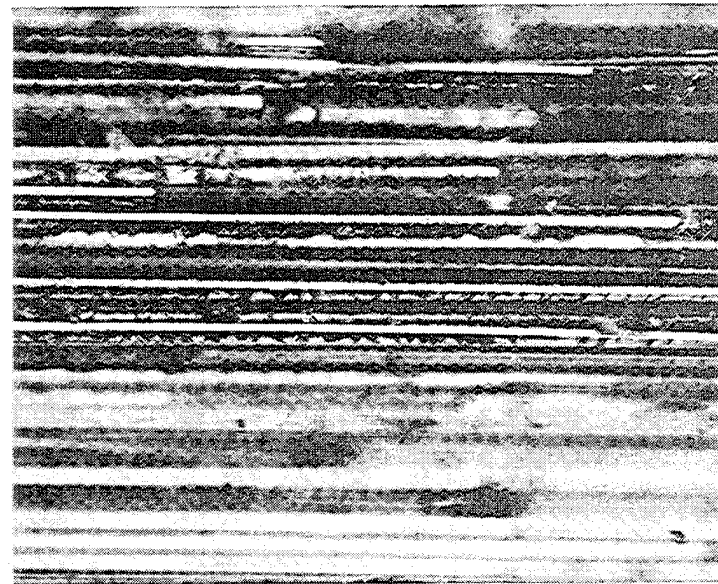
Figure 3.2-17. Optical Fractographs of KII/ASA Interlaminar Mode II (Shear) Fatigue, 350° F, High Stress
